**PROTECTING YOUR POLYURETHANE
FOAM ROOF SYSTEM**

Problems with Polyurethane Foam Roofs

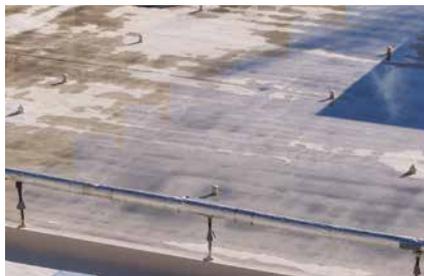
- Foam roof systems should be inspected at least twice a year and be coated every 5-7 years. If inspections are not done to detect and correct damage, foam roof systems will not provide secure water-shedding.
- Foam roofs face damage from a wide variety of elements ranging from sun, birds, bugs, hail, and other damaging weather conditions.
- When white protective coatings become thin, the underlying foam can be quickly damaged. The sun's UV rays “burn” the foam and cause premature deterioration and failure. Once the foam has started to burn, water intrusion becomes a problem.
- Unprotected foam roofs act like a sponge and the water that gets through its protective layer can cause the foam to delaminate from the decking and form blisters throughout the roof system.

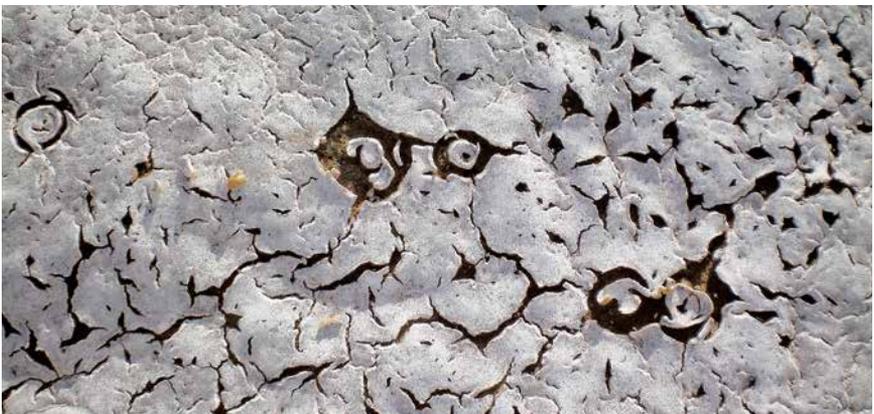
Example of damage caused by water intrusion on a foam roof.

Recoating a foam roof reseals the roof and limits moisture intrusion. Water near the surface can cause blistering in the roof coating or de-lamination of the upper layer of foam. Water at the deck level below the foam can eventually lead to foam de-laminating from the deck surface, causing foam “domes.”
